PHASE I INSPECTION REPORT
NATIONAL DAM SAFETY PROGRAM

17. DISTRIBUTION: National Dam Safety Program. Wanaksink Lake Dam, Delaware River Basin, Sullivan County, New York. Phase I Inspection Report. (Inventory Number NY 330)

PHASE 1 INSPECTION REPORT
NATIONAL DAM SAFETY PROGRAM
WANAKSINK LAKE DAM I.D. No. NY 330
DEC #195 DELAWARE RIVER BASIN
SULLIVAN COUNTY
(FORMERLY LORDS RESERVOIR DAM)

Date of Inspection: November 15, 1978

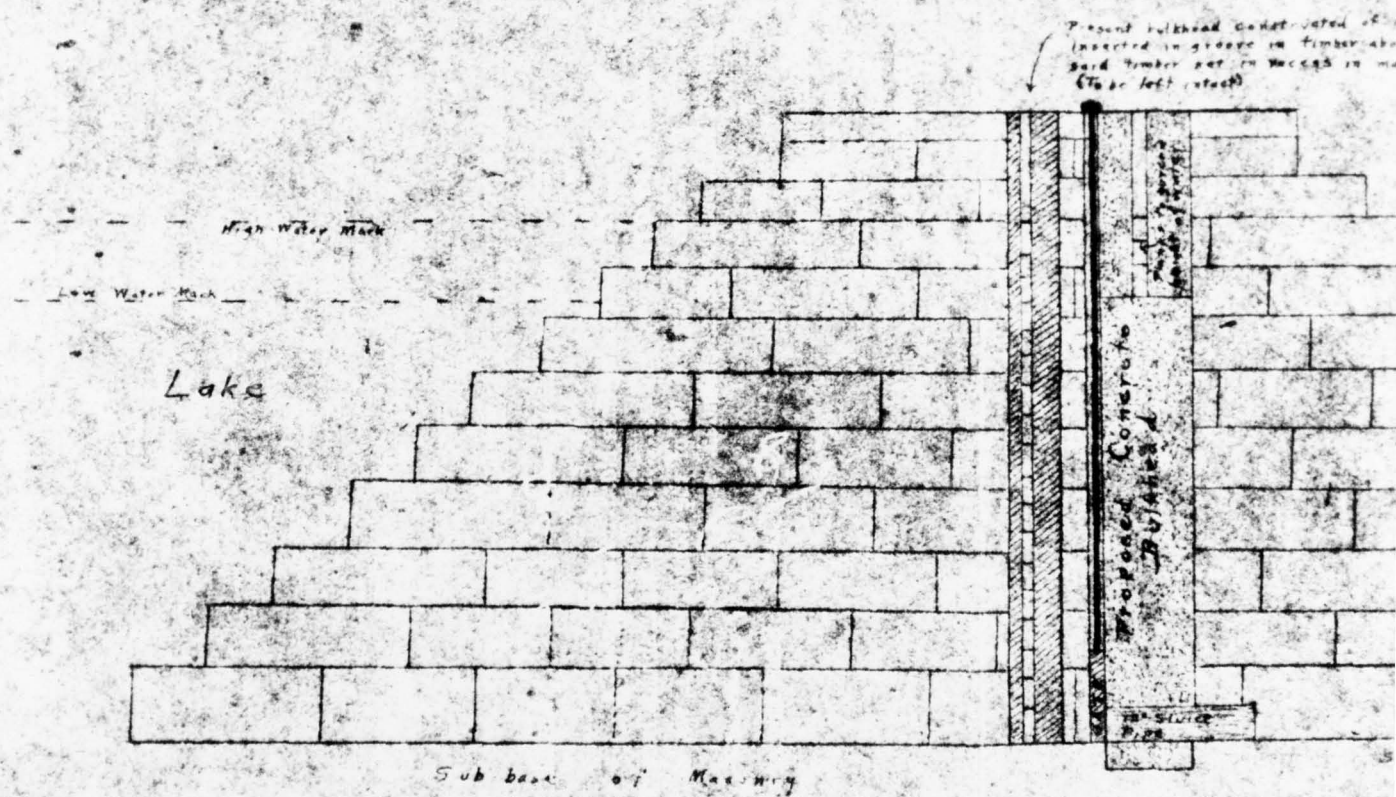
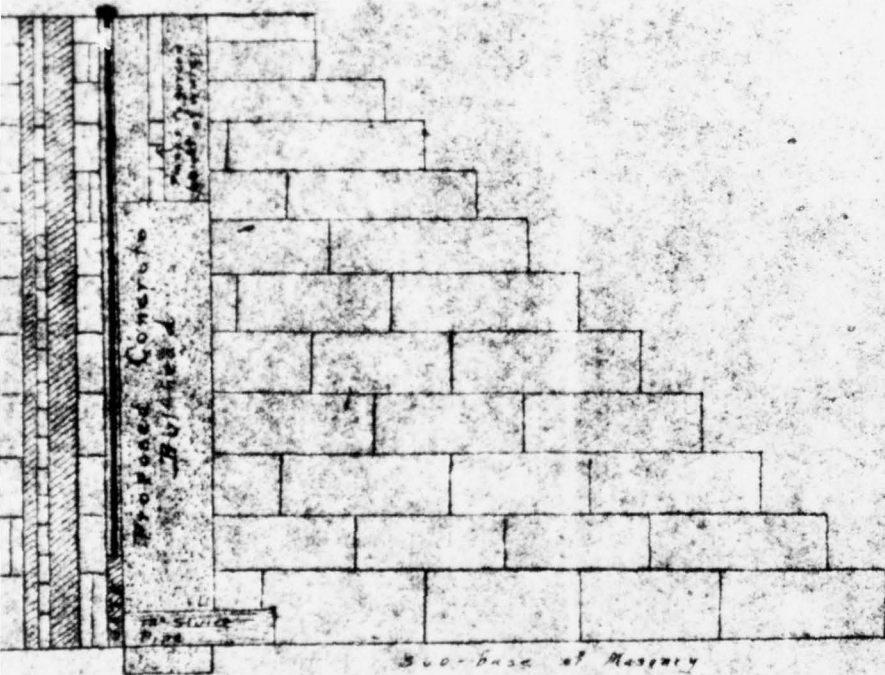
Proposed Concrete Bulkhead

Present bulkhead constructed of 8" x 6" planks
 inserted in grooves in timber about 16" x 16"
 Solid timber set in recess in masonry.
 (To be left intact)
